External Quality Assessment Scheme

Prenalytics and process in anatomic pathology Round 2, 2022

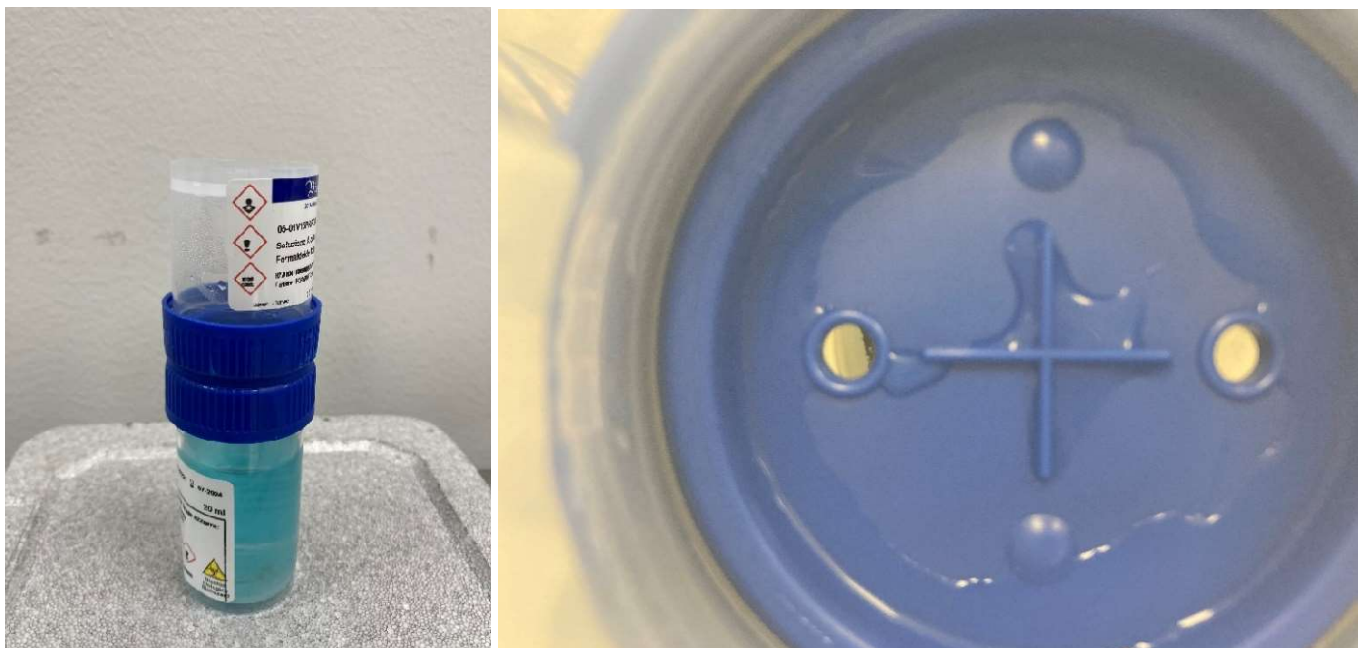
Figure 1. Safety container of formalin. The fixative has been properly released into the container from the upper fixative part of the container. After releasing the formalin, the cap should be closed tightly.

Usually, two different types of deviations can occur with the type of safety container shown in the picture. Deviations affect the quality of the tissue sample. The sample can remain in the buffer part of the two-part safety container and formalin is not released into the buffer containing part of the container. In this case, the sample cannot be fixed properly, and autolysis weakens the quality of the sample. Formalin is released through the holes of the cap and common deviation is that the holes should be closed after releasing of the formalin. During transport, small samples can move through the holes to another part of the jar. The sample may remain dry or not all samples can be found in the jar. It should be noted that the formalin part of the container cannot be opened.

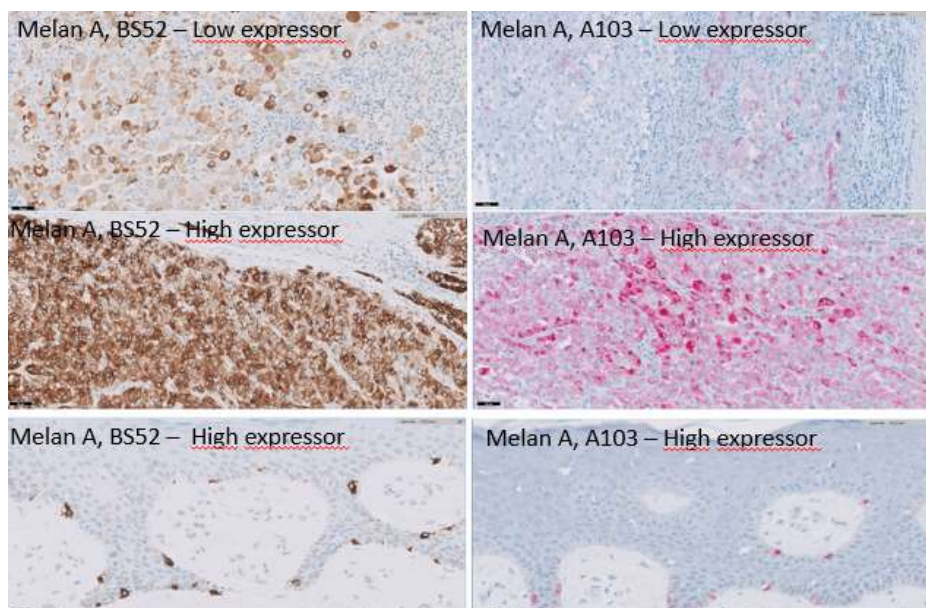
Figure 2: Comparison of the different Melan A clones using melanoma and skin sections.
